DEVELOPMENT OF IMPROVED PROCEDURES FOR MANAGING PAVEMENT MARKINGS DURING FDOT HIGHWAY CONSTRUCTION PROJECTS

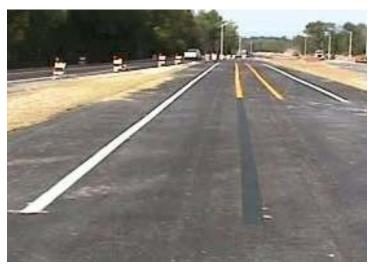
Figure 1 Photograph of Modified Sand Seal Installation

The second approach involved the development of a modified sand seal coating. In this method, a traditional sand seal application was modified by increasing the asphalt temperature and by utilizing concrete fine aggregate. The increased temperature shortened the break time for the asphalt, and the angular sand improved the friction properties. A test section was installed on a construction project. Locked-Wheel friction tests were performed to measure friction performance. The covering suitability and durability of the covering were observed.

installed at less cost than the use of the current water blasting and grinding removal methods. Figure 1 provides a photograph of the modified sand seal installation.

The modified sand seal coating provided exceptional performance with regard to friction, coverage, and durability. The materials and equipment required for installation are normally found on paving projects. Cost estimates indicate that the modified sand seal coating can be

The sand seal covering proved to be a practical and successful method for covering temporary pavement markings. The sand seal covering method offers the following advantages:
